**The Home Report, LLC**  
Real Estate Inspection Service

## Sample Inspection Report Photos

<b>Inspection Date:</b>	1/12/2012
<b>Document #:</b>	12-140
<b>Client:</b>	<b>John and Mary Smith</b>
<b>Location:</b>	1234 NW Main Street, Unit 411, Seattle, WA
<b>Realty Agent and Co.:</b>	Jean Jones - Seattle Real Estate Co.
<b>Inspector:</b>	Donald Lawn, WA State Lic. # 320

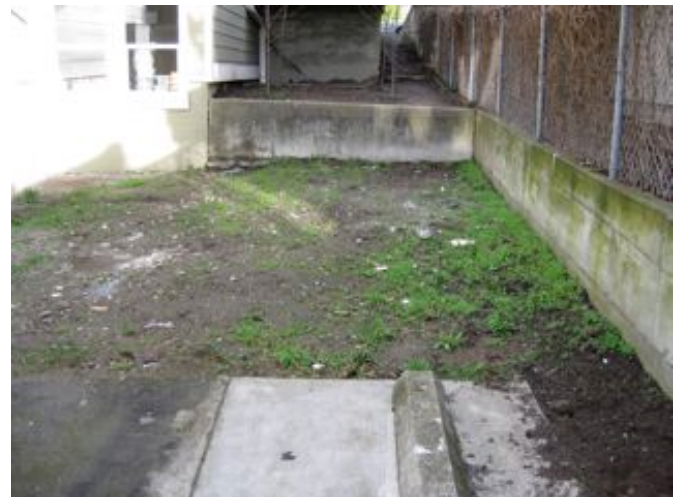
Back grounds with debris

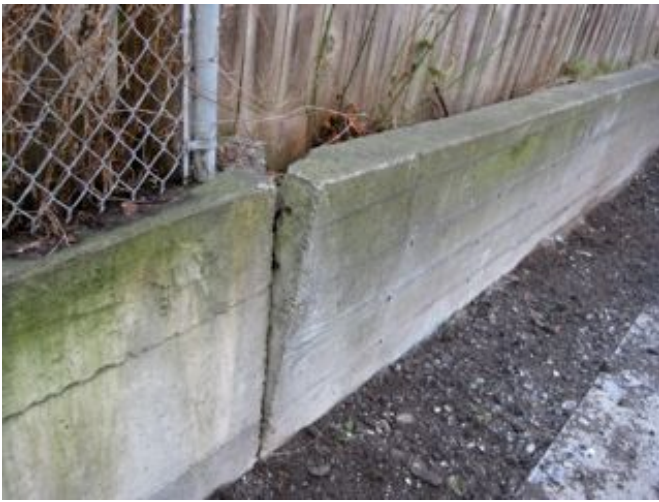
Settled retaining wall at parking

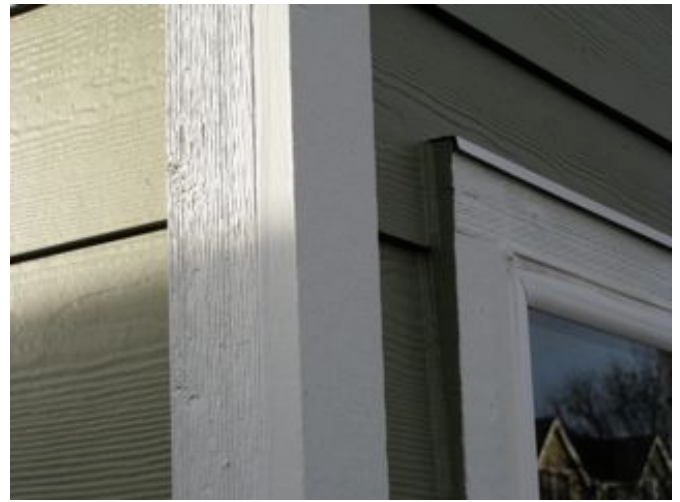
Mostly good siding details

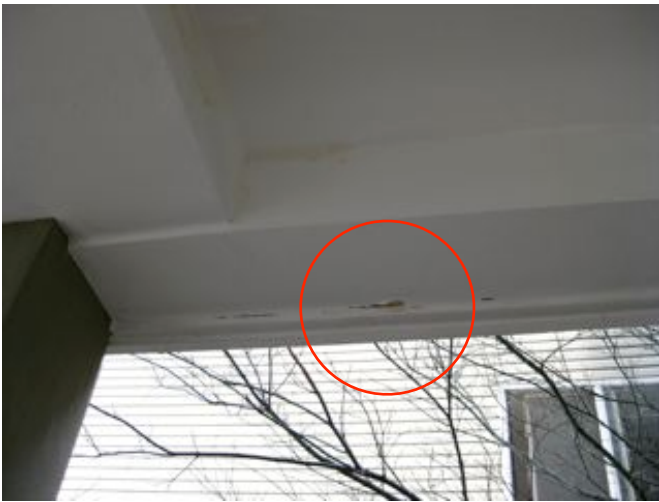
Minor leak at underside of north parking

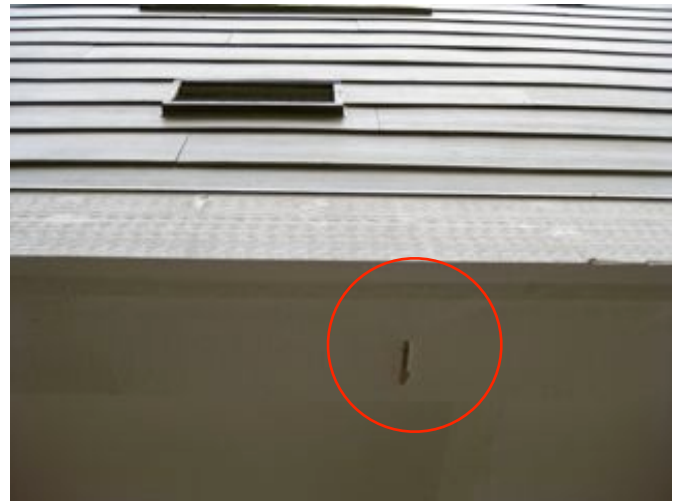
Minor leak at underside of north parking

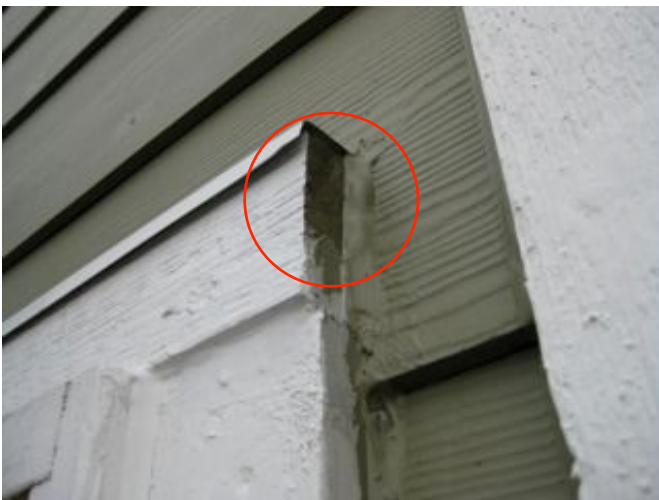
Unpainted trim ends

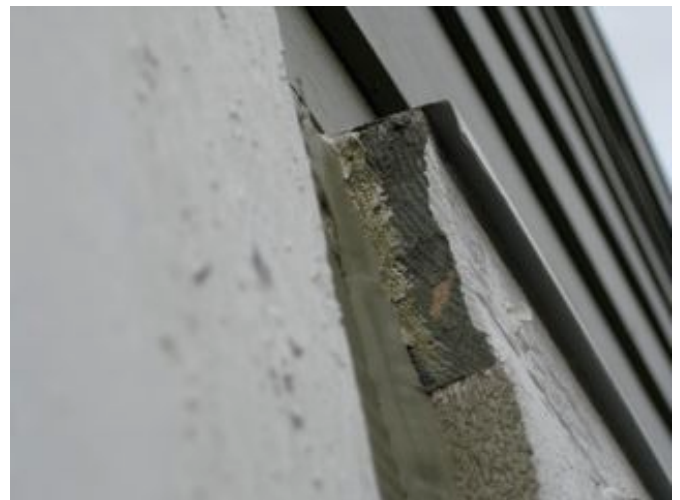
Unpainted trim ends

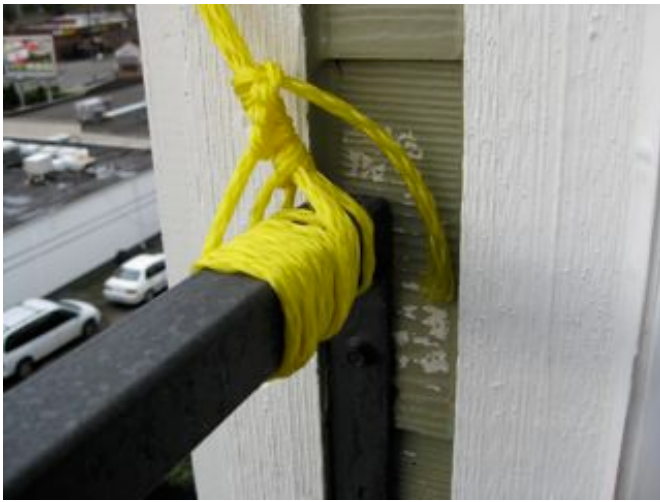
Peeled paint

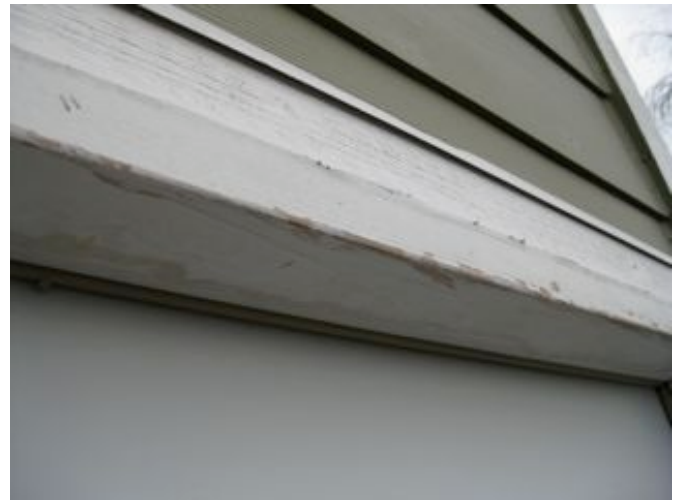
Peeled paint - primed

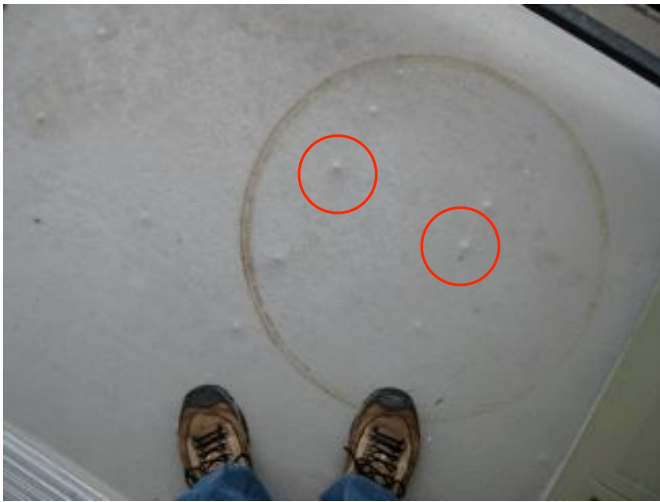
Popped nails at deck

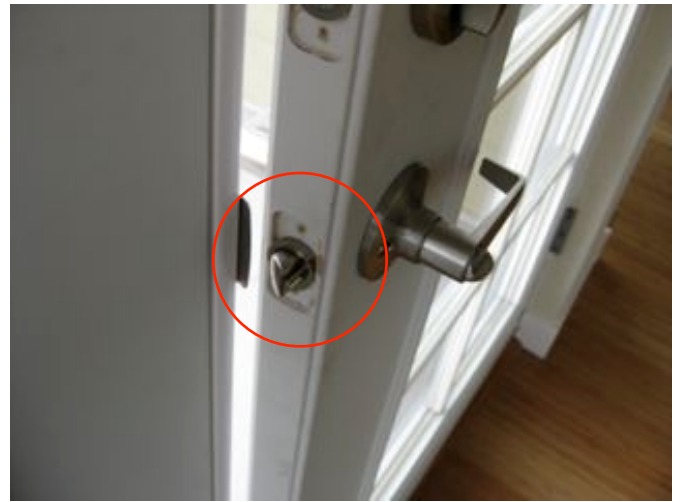
No door hasps

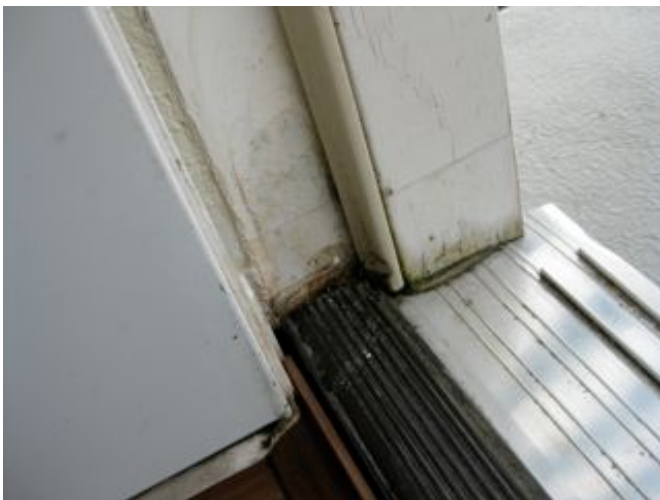
Moisture marks at deck door jamb

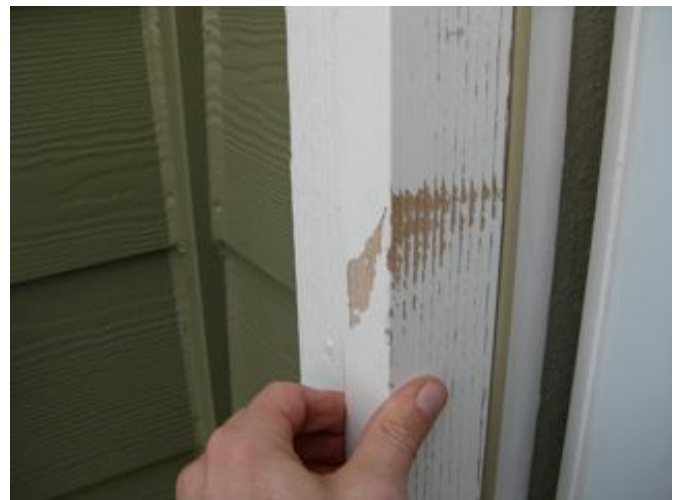
Peeled door trim

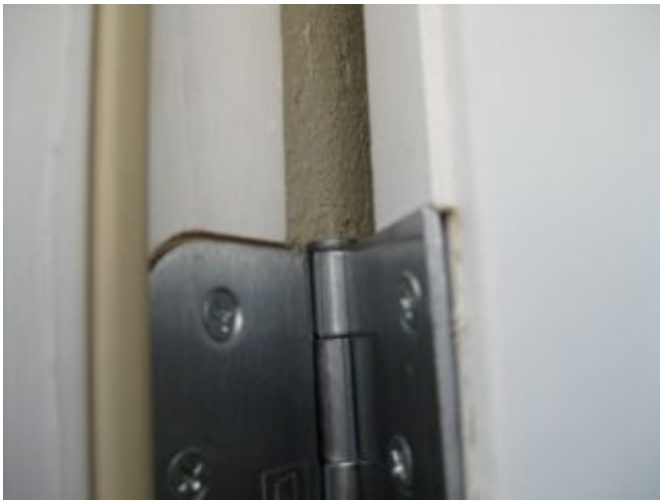
Mis-aligned door hinge

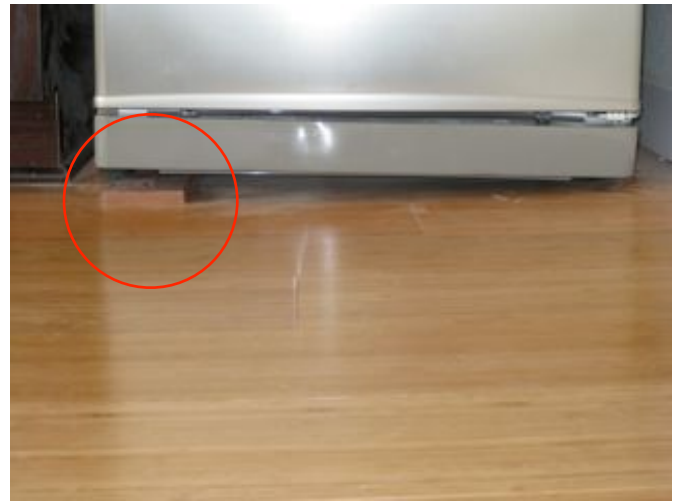
Shimmed refrigerator

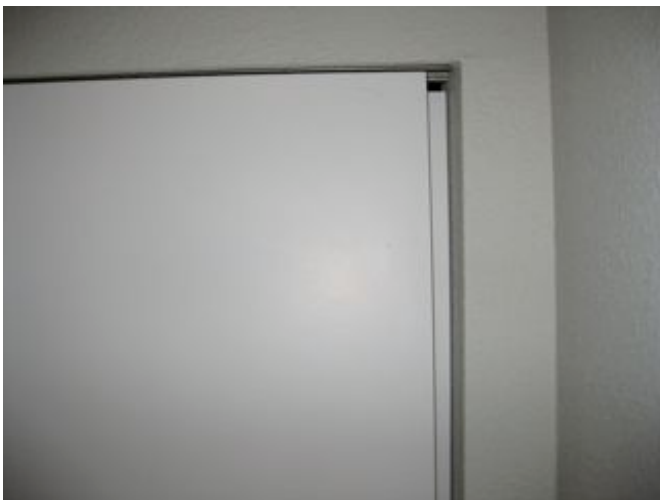
Uneven gaps at closet doors due to settling

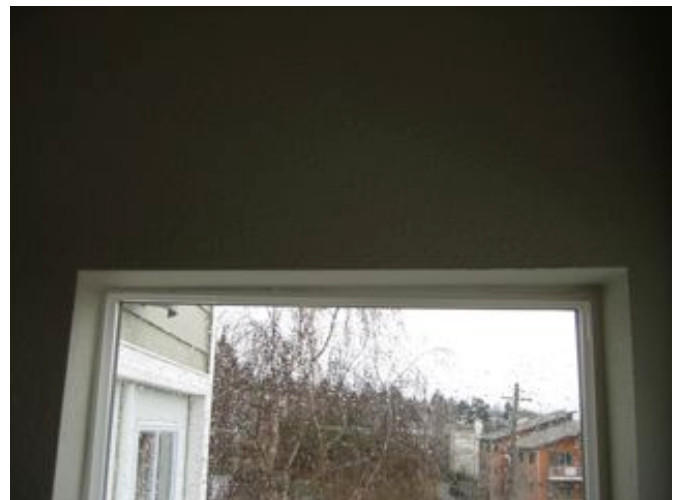
Uneven gaps at kitchen window due to settling

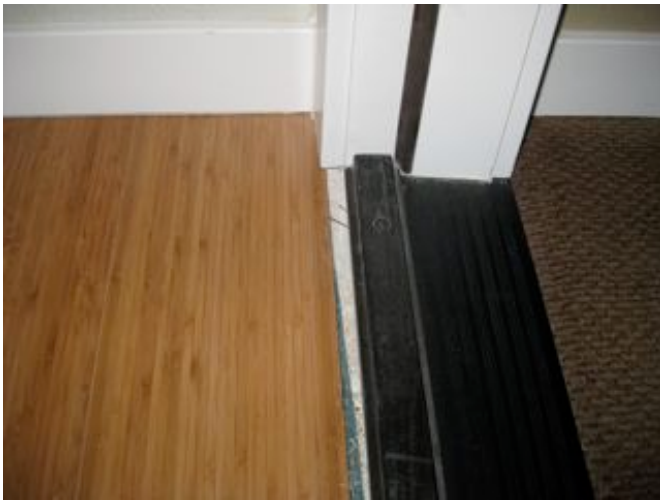
Gap at loose threshold entry

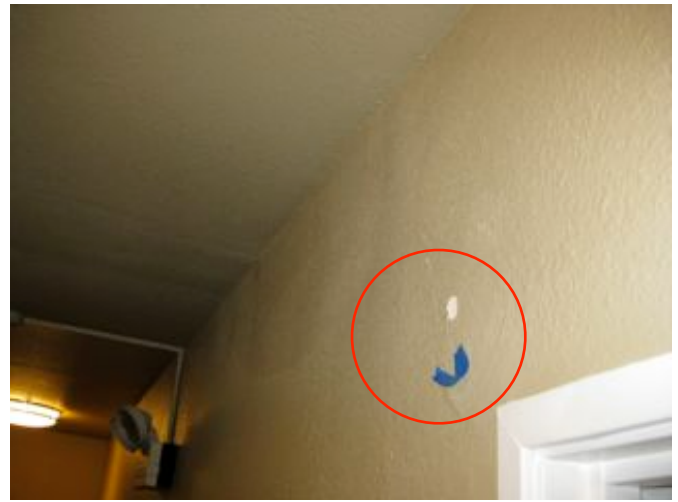
Old hall water marks

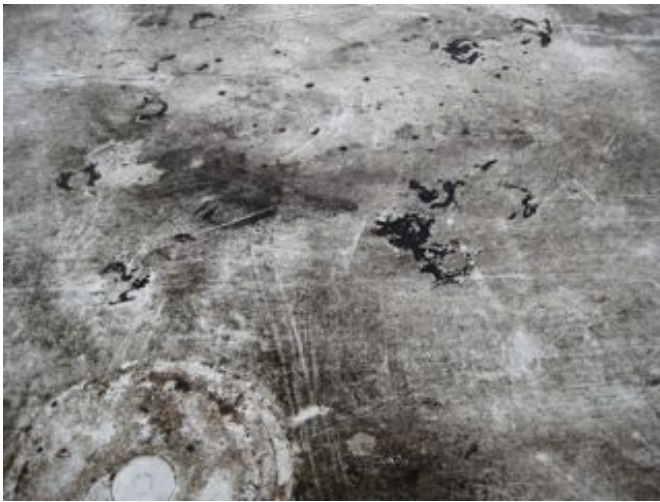
Dirty roof

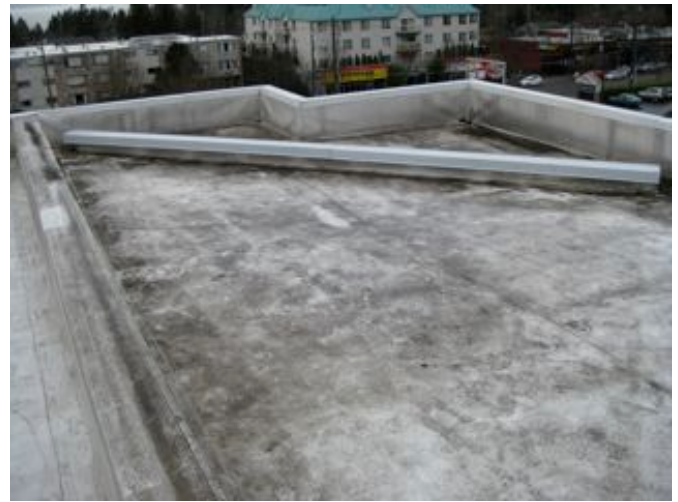
Dirty roof

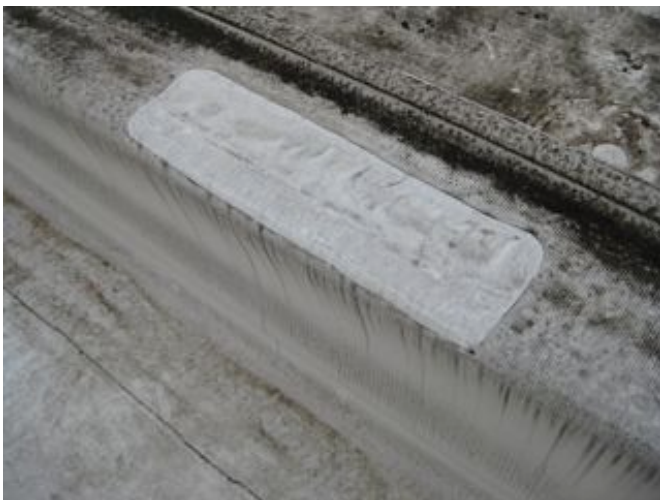
Patched roof

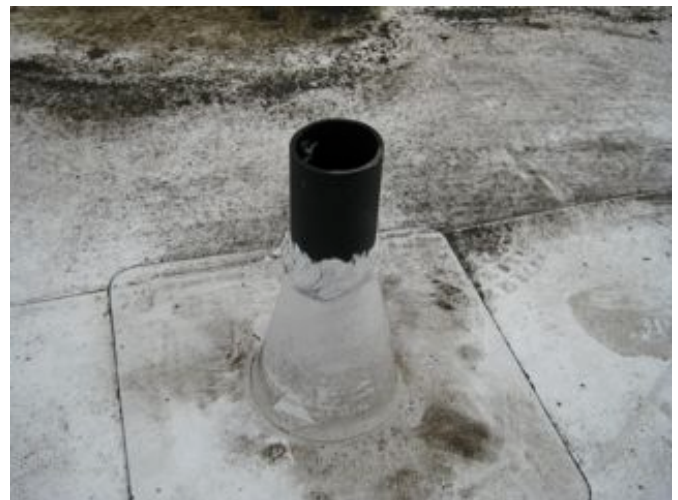
Caulk at roof penetrations

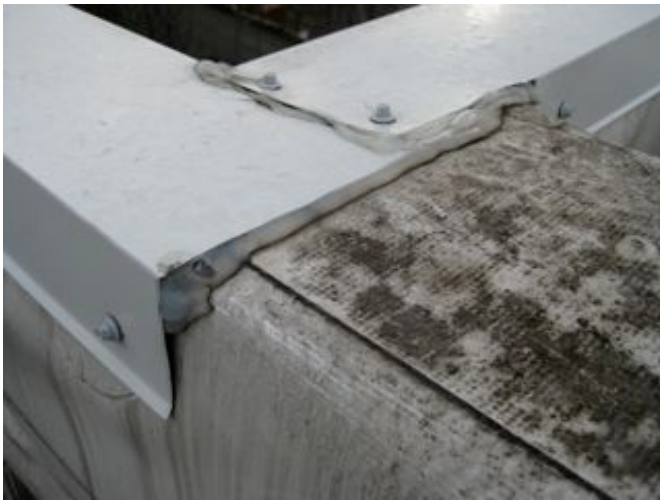
Good caulk at roof flashing

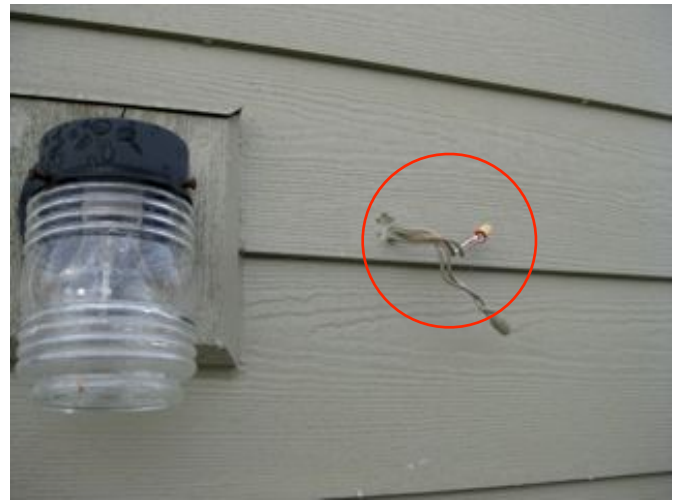
Electrical wires at roof wall

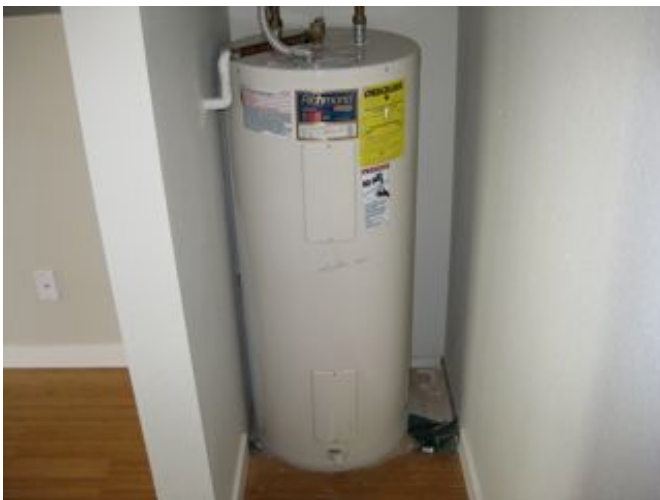
Old hot water tank

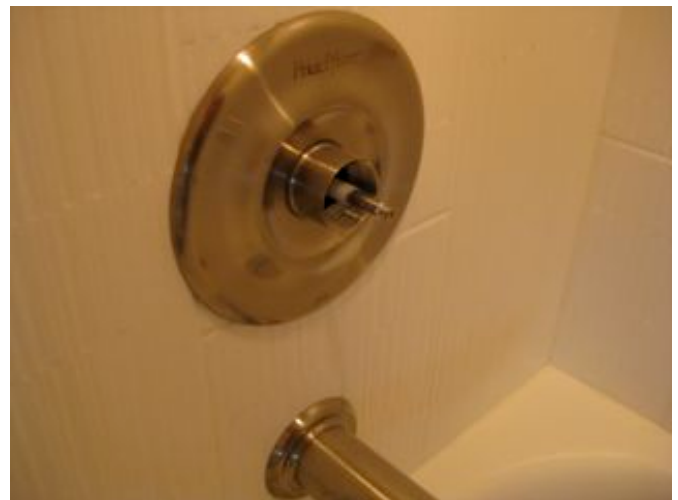
Missing tub diverter valve

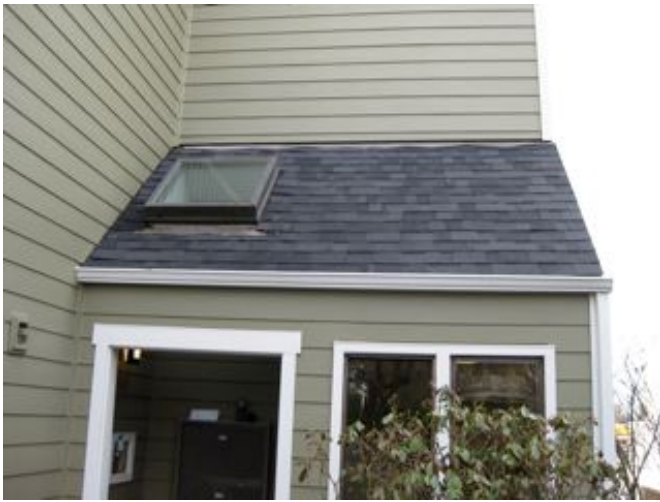
Newer front roof

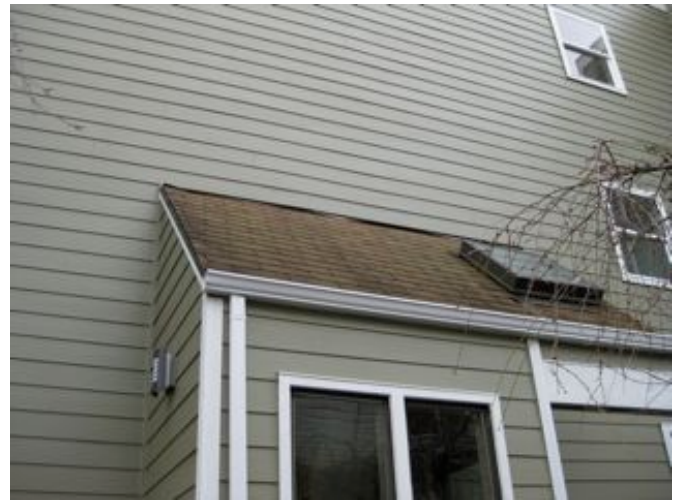
Older front roof

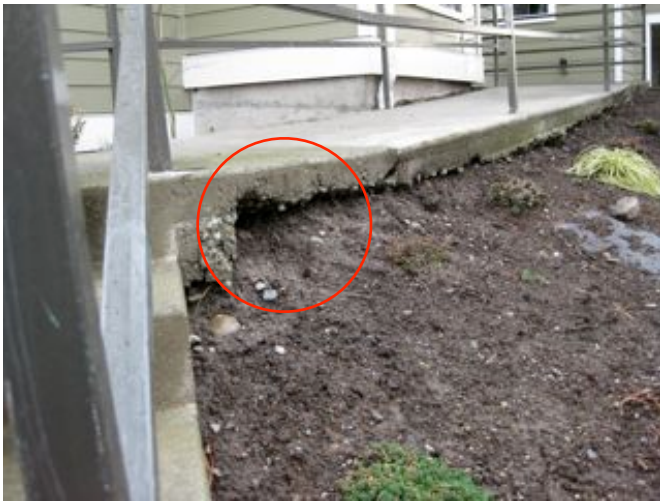
Minor voiding

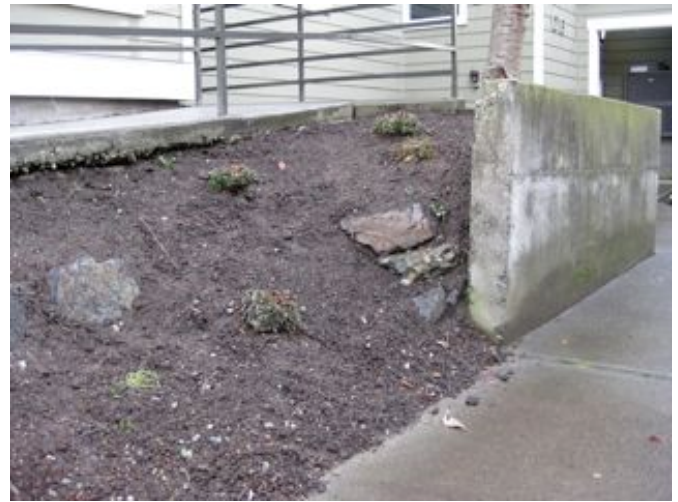
No retention at entry

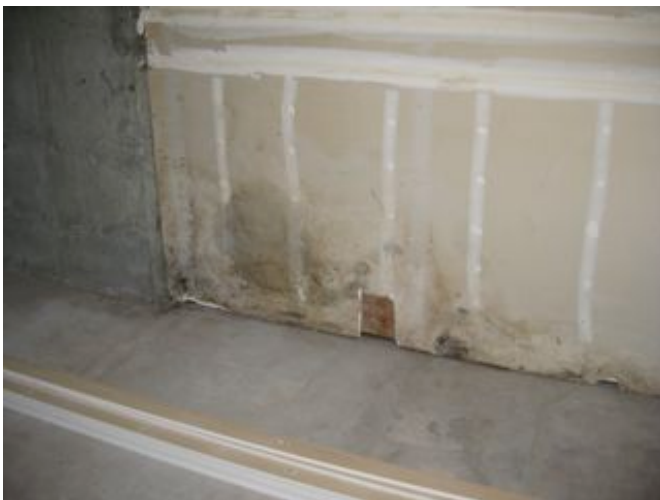
Moldy drywall at basement storage
